Special Investigation Report
Recent Accident History of Hot Box
Detector Data Management

SPECIAL INVESTIGATION REPORT

**RECENT ACCIDENT HISTORY
OF HOT BOX DETECTOR
DATA MANAGEMENT**

NTSB-SIR-81-1

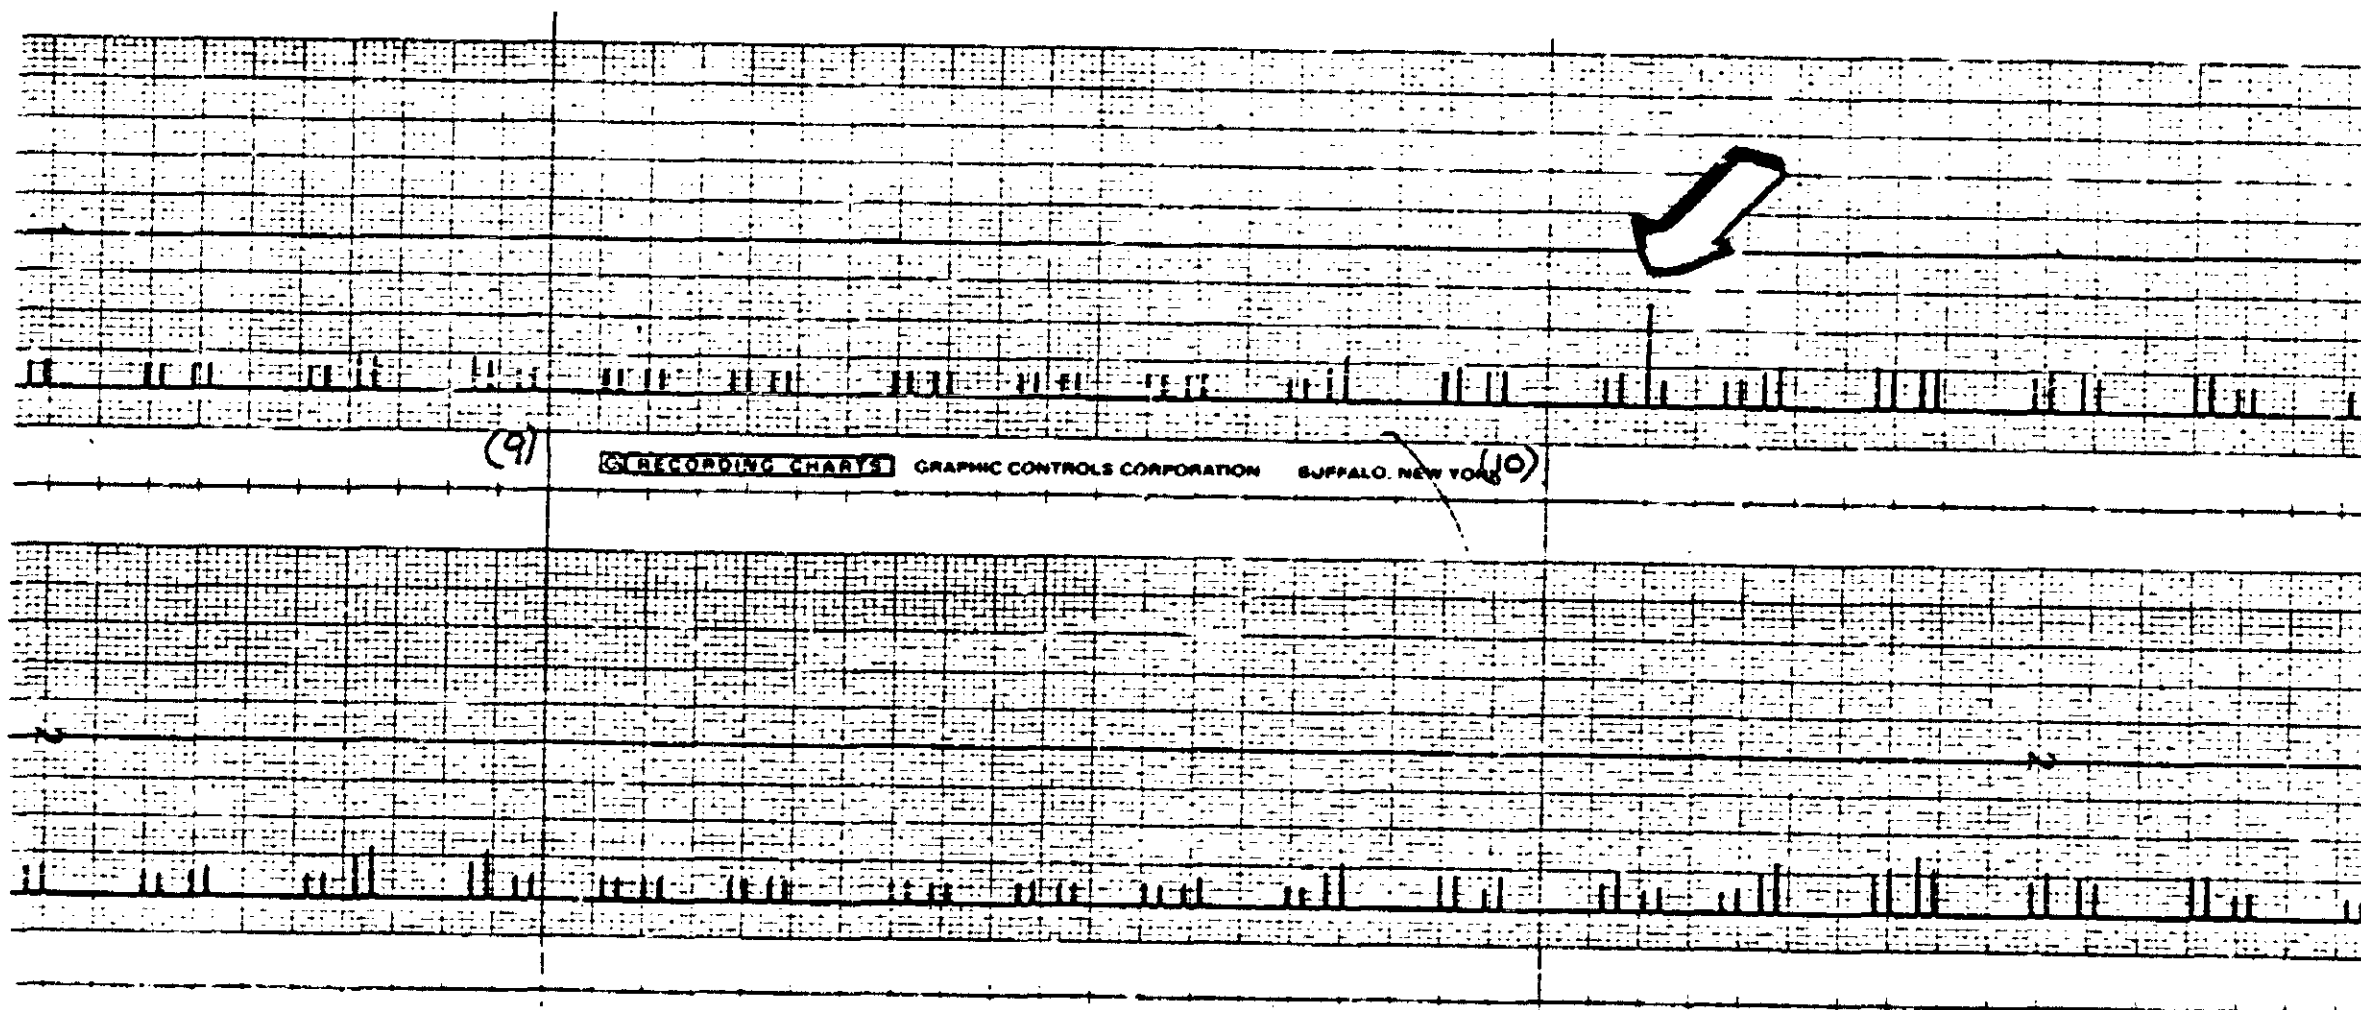
Figure 2.--Typical Hot Box Detector Remote Recorder Display.
(Arrow indicates overheated journal bearing.)
